An Taisce
The National Trust for Ireland

Buildings at Risk

November 2014

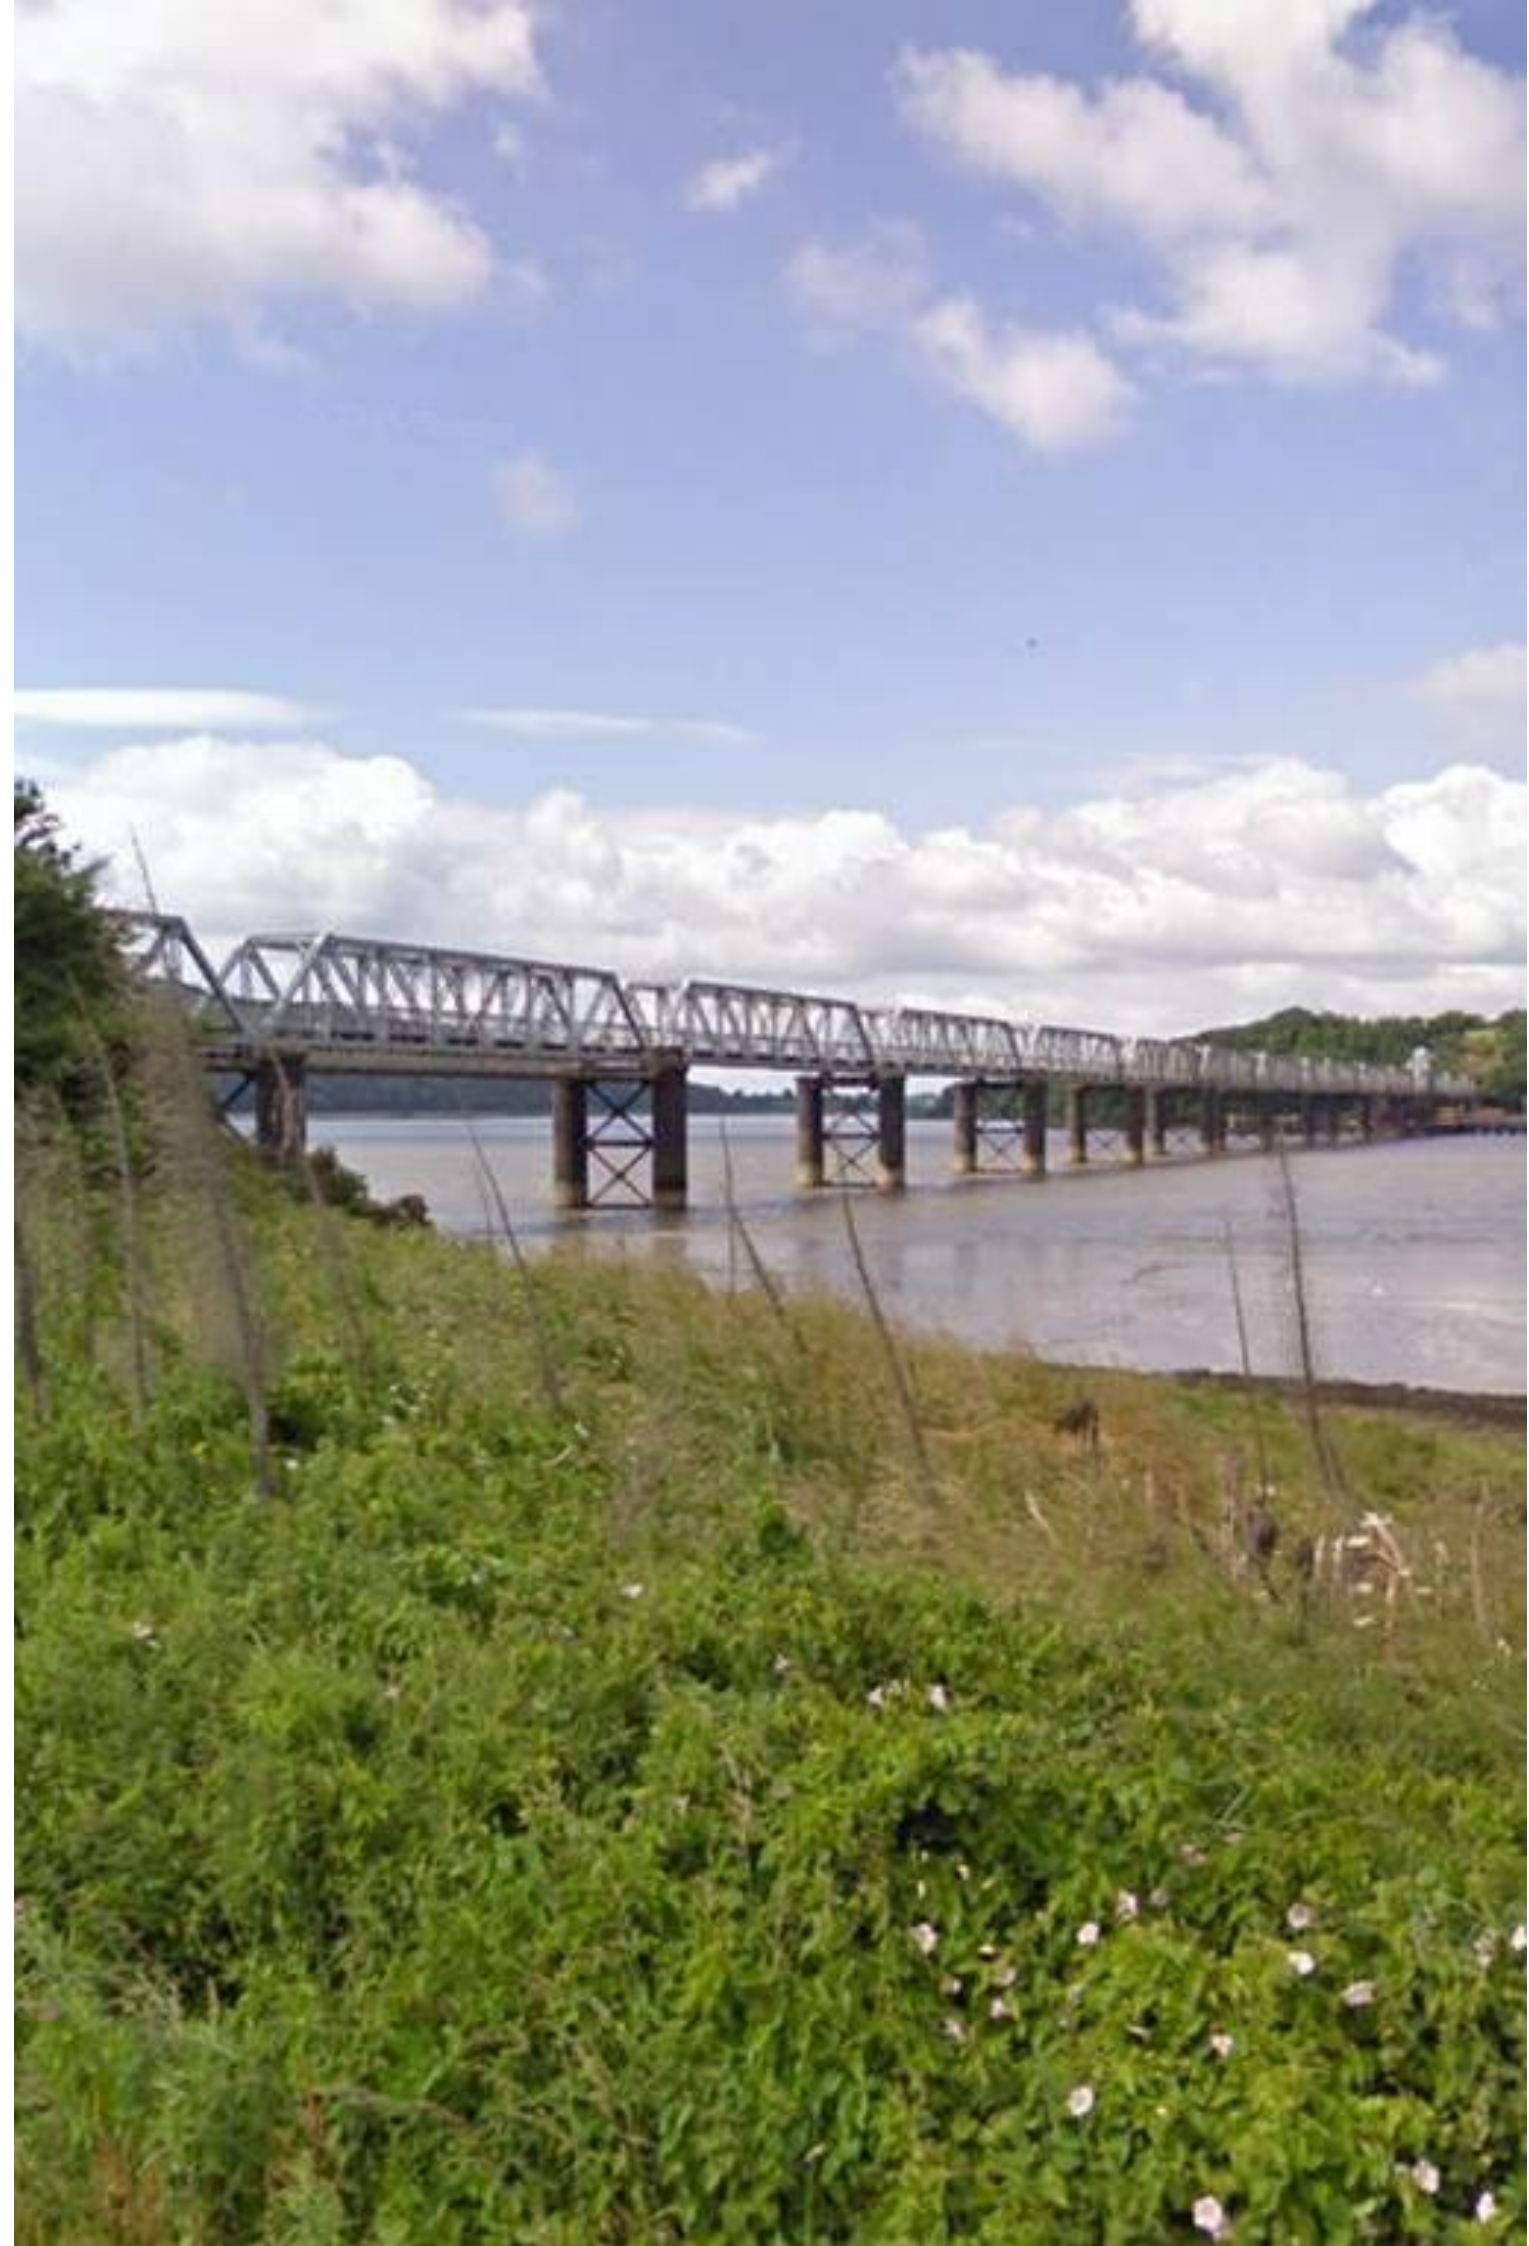
Woodstock House

Condition of Structure	Ruinous
Level of Risk	High

Woodstock is a ruin of a substantial mid 18th century house built by Sir William Foyne and extended in early 19th century with wings by the Tighe Family. It was burnt down in 1921 following occupation by the Black and Tans. A central section of the facade of the main block collapsed in the 1990s. It was acquired with the adjoining garden and arboretum by Kilkenny County Council who have carried out major restoration since 1999. Additional major work is required to secure ruin from further deterioration. The structure is of significant historic importance and requires conservation works to prevent further deterioration.

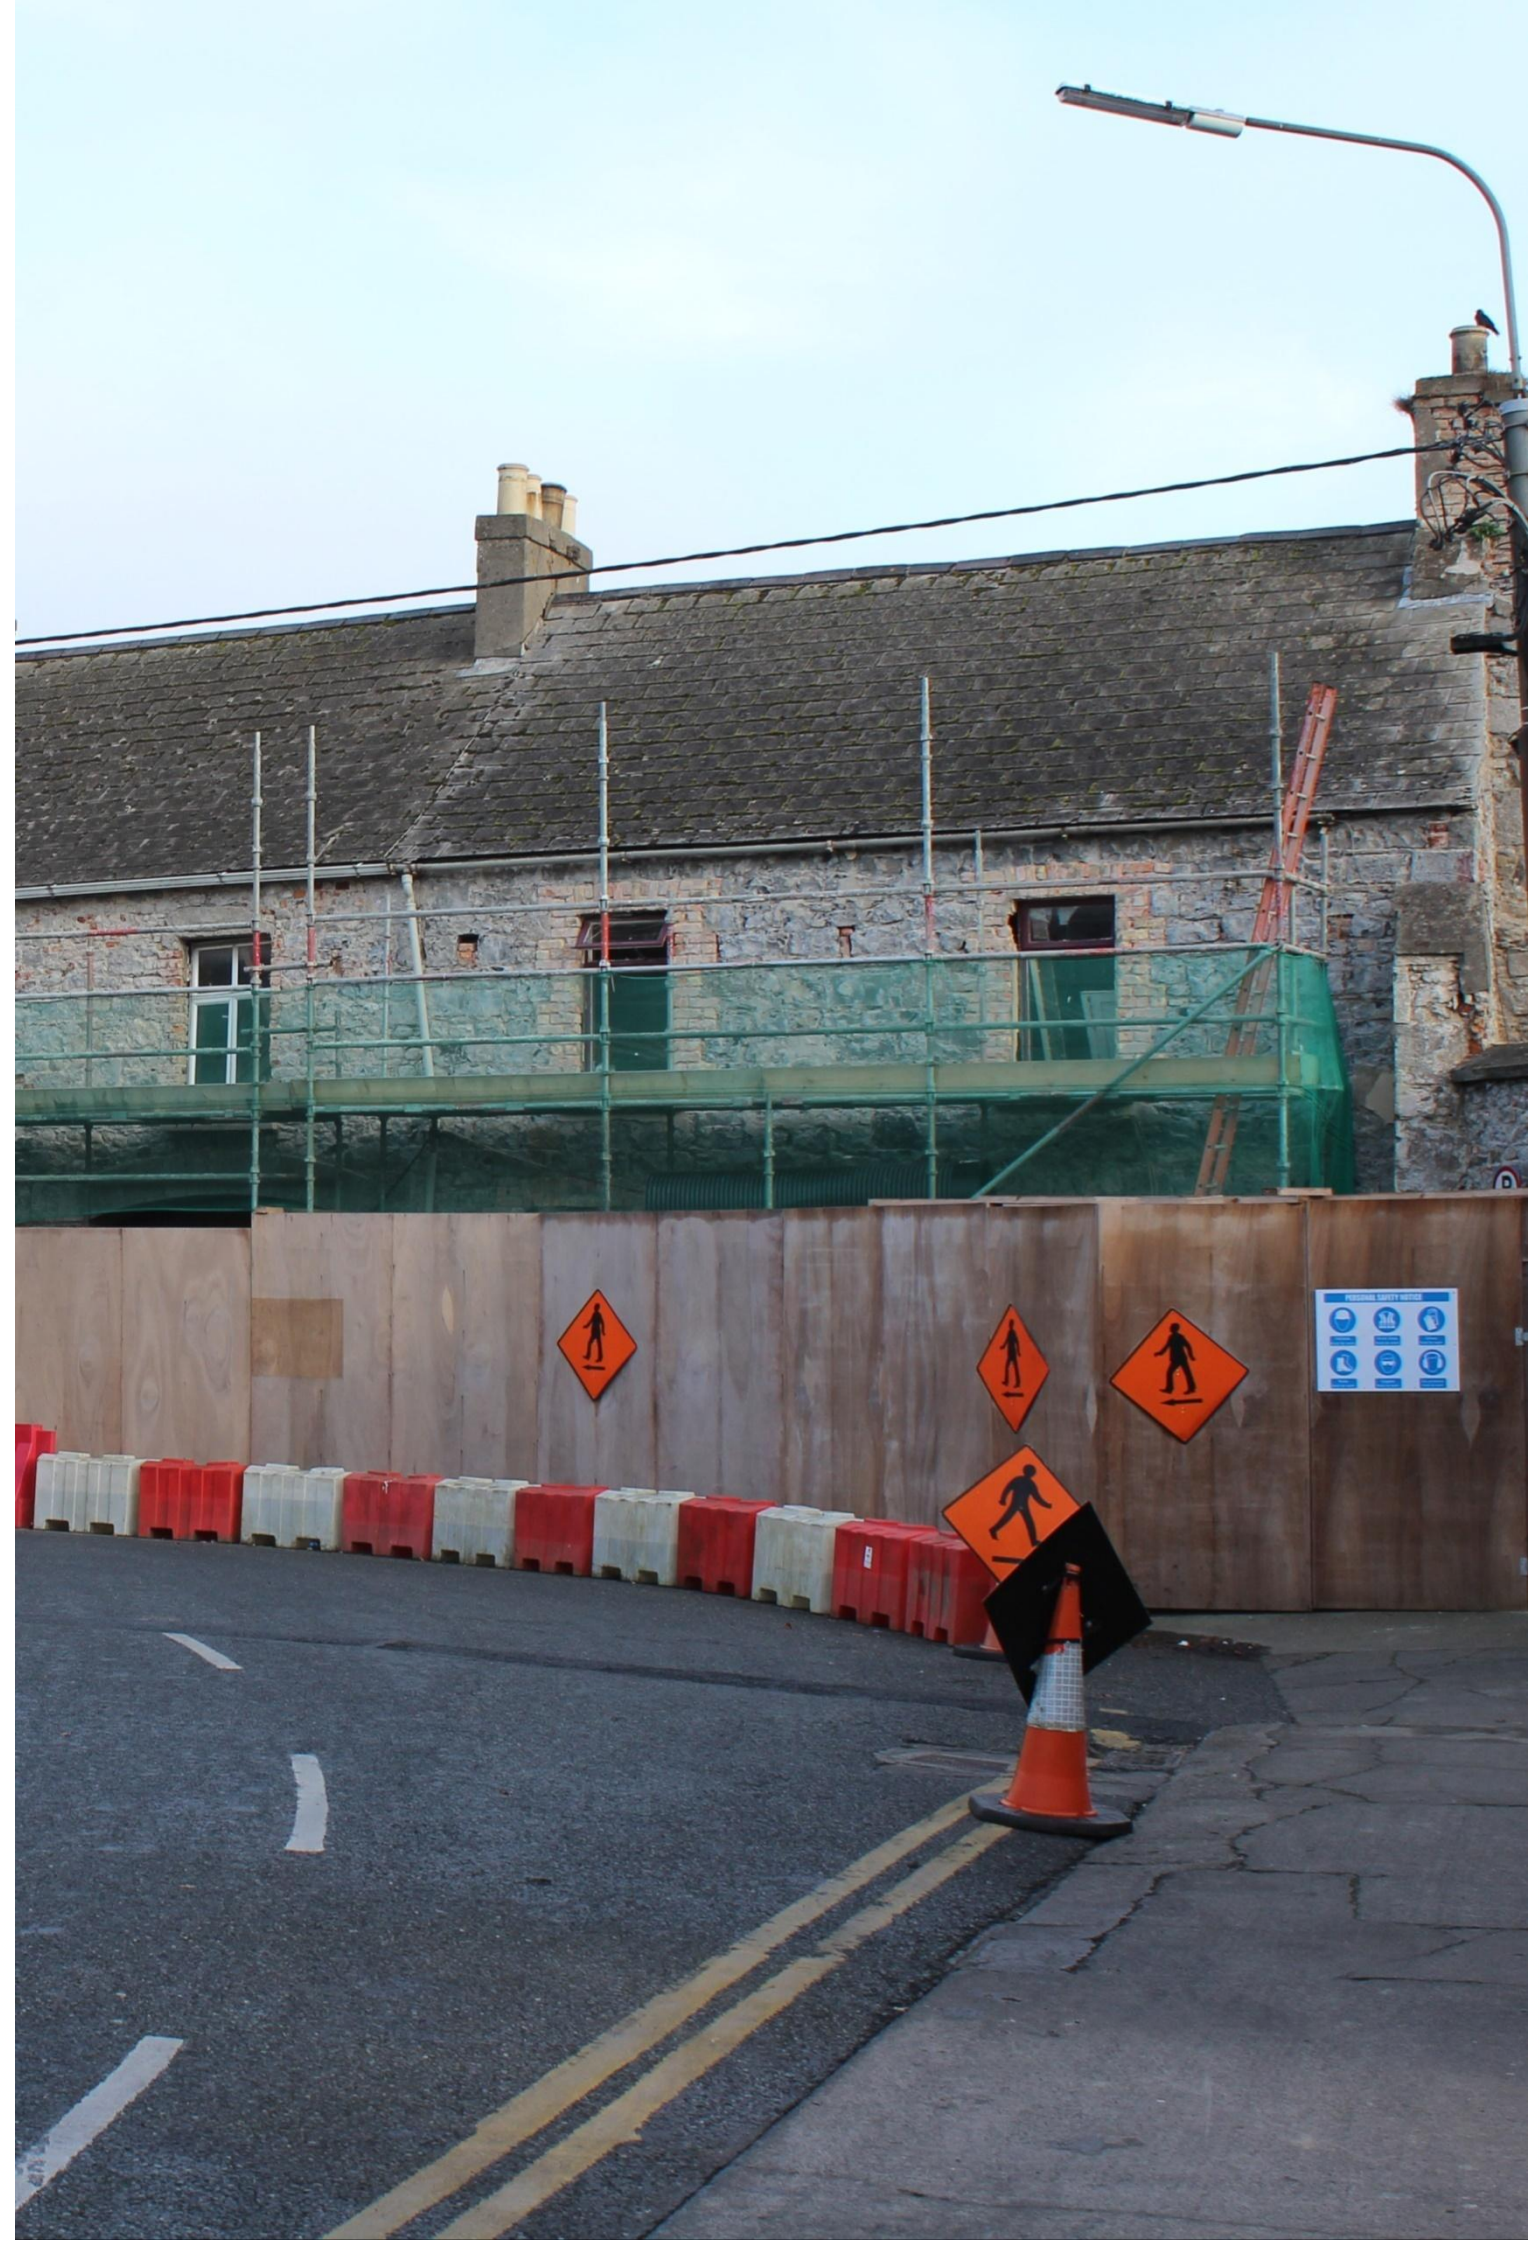
Dysart Castle is a pre Anglo-Norman ecclesiastical site with medieval towers which was built when the site was a dependency of Kells Priory. The castle was home to the Bishop George Berkeley. The structure is of significant historic importance and requires conservation works to prevent further deterioration.

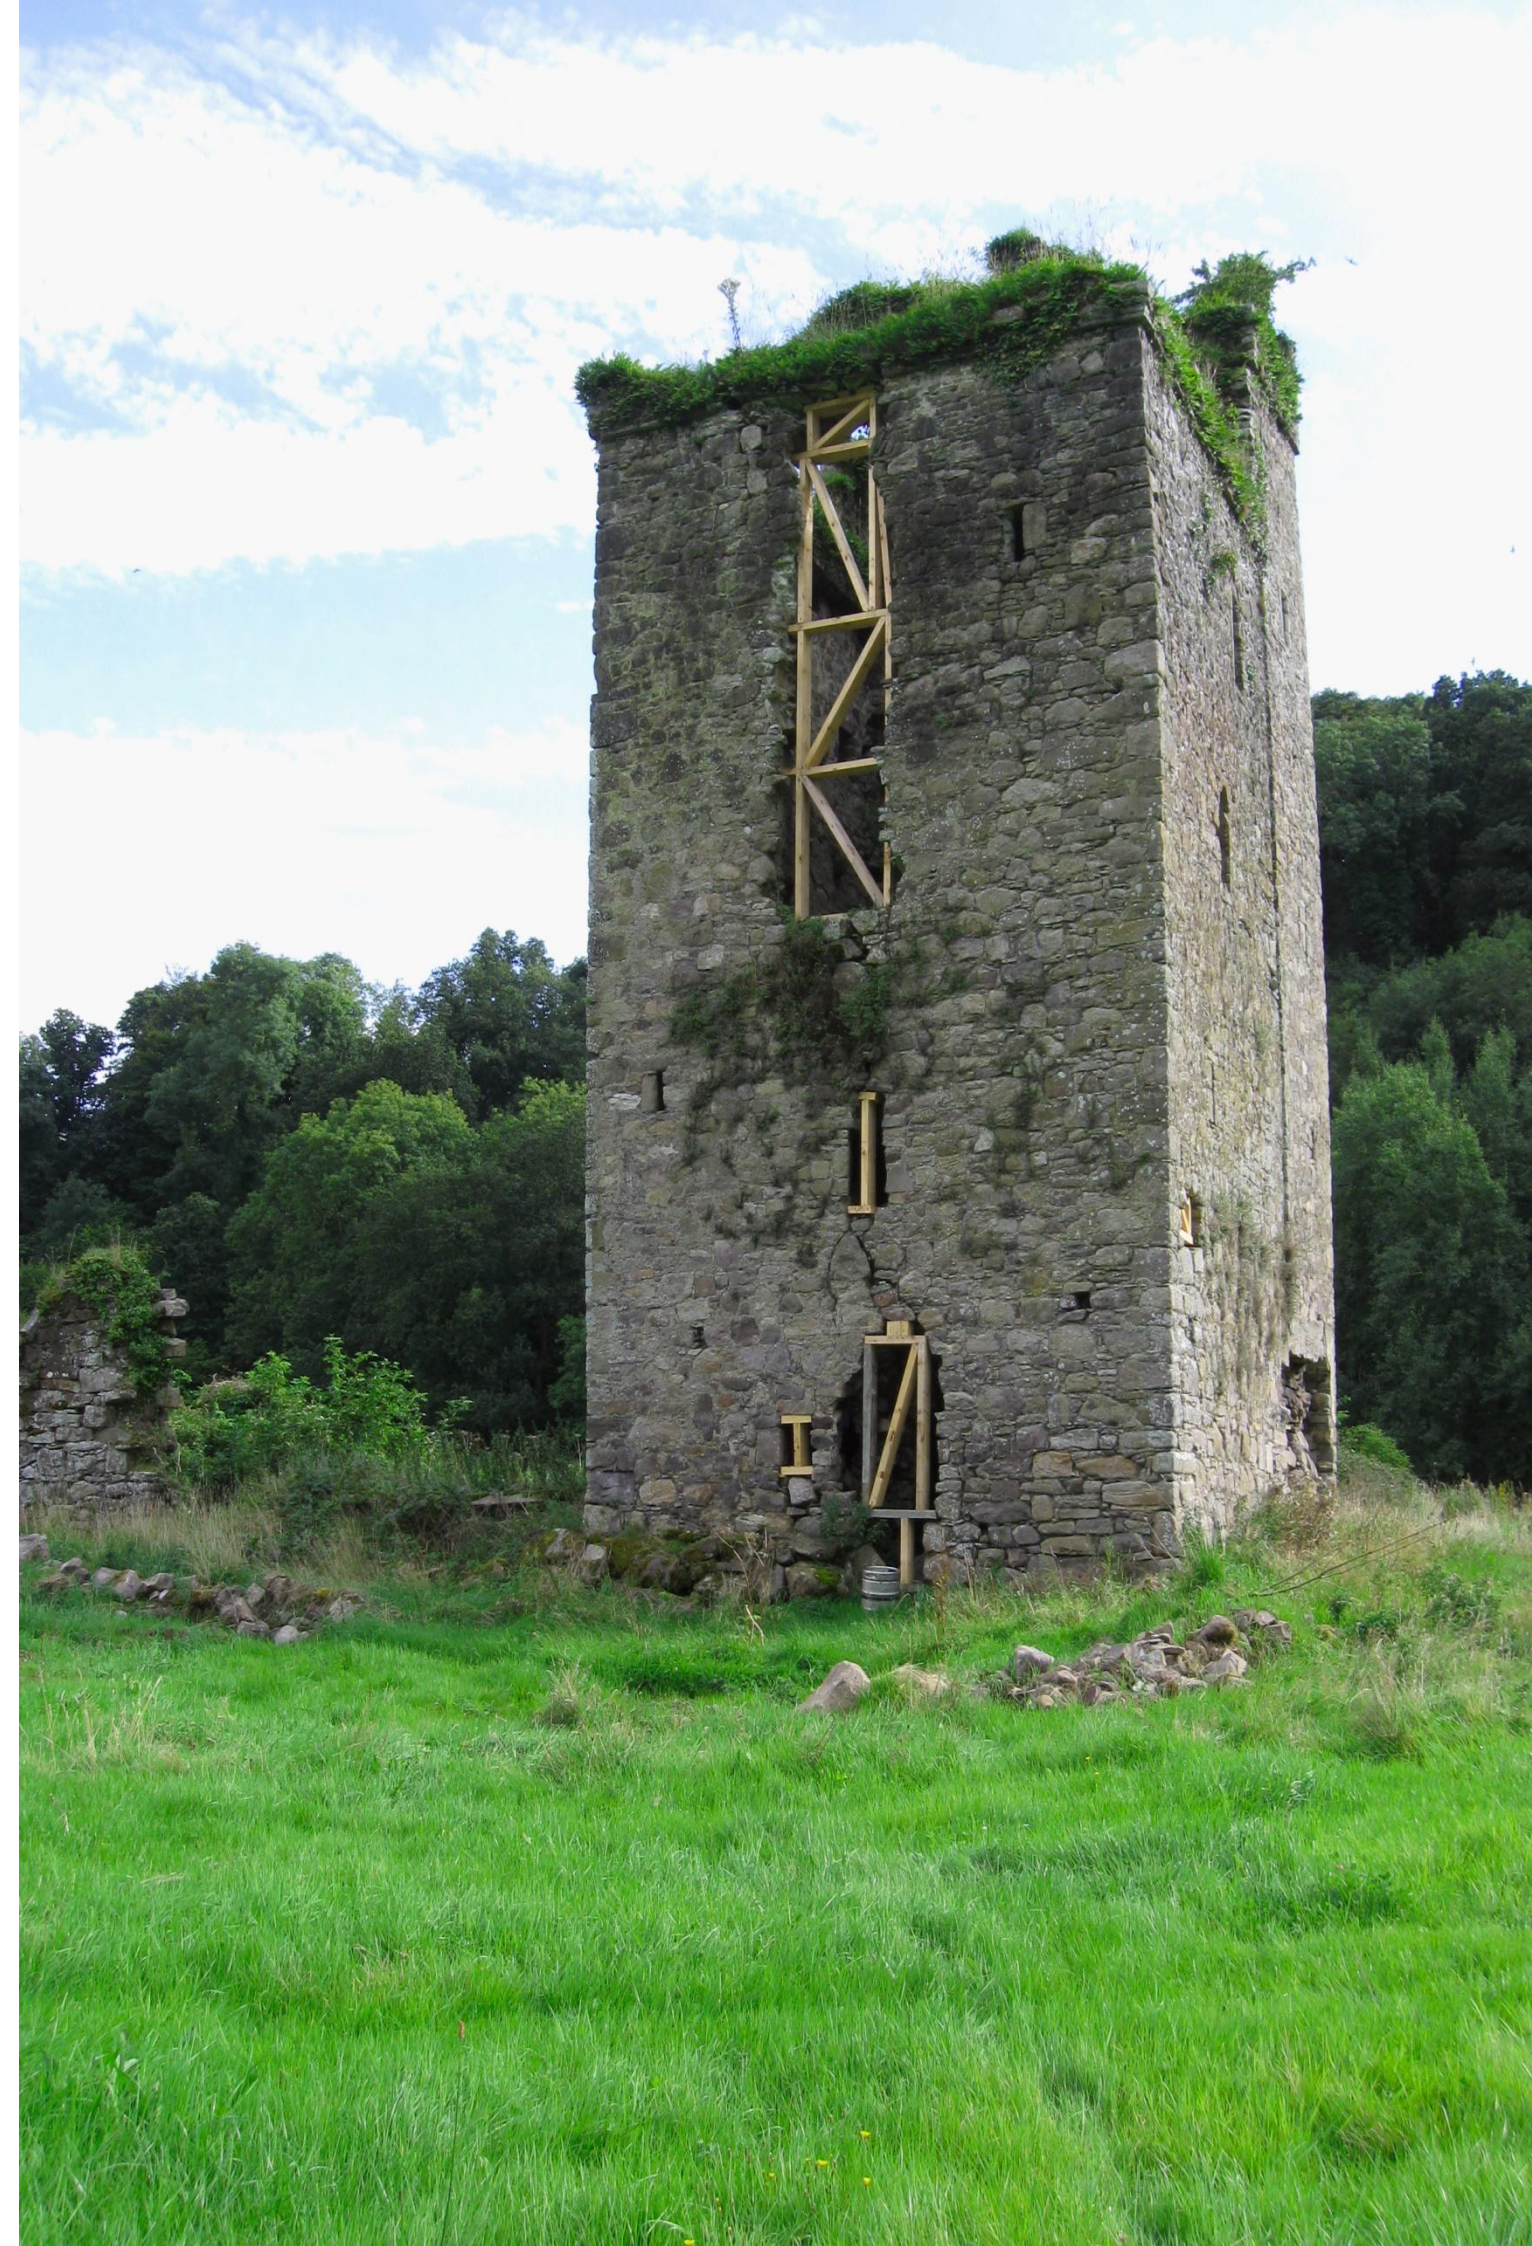
Sweetman's Castle

Sweetman's is a late medieval tower retaining original cronellations in a prominent location beside the River Nore. The building is of significant historic importance and requires conservation works to prevent further deterioration.

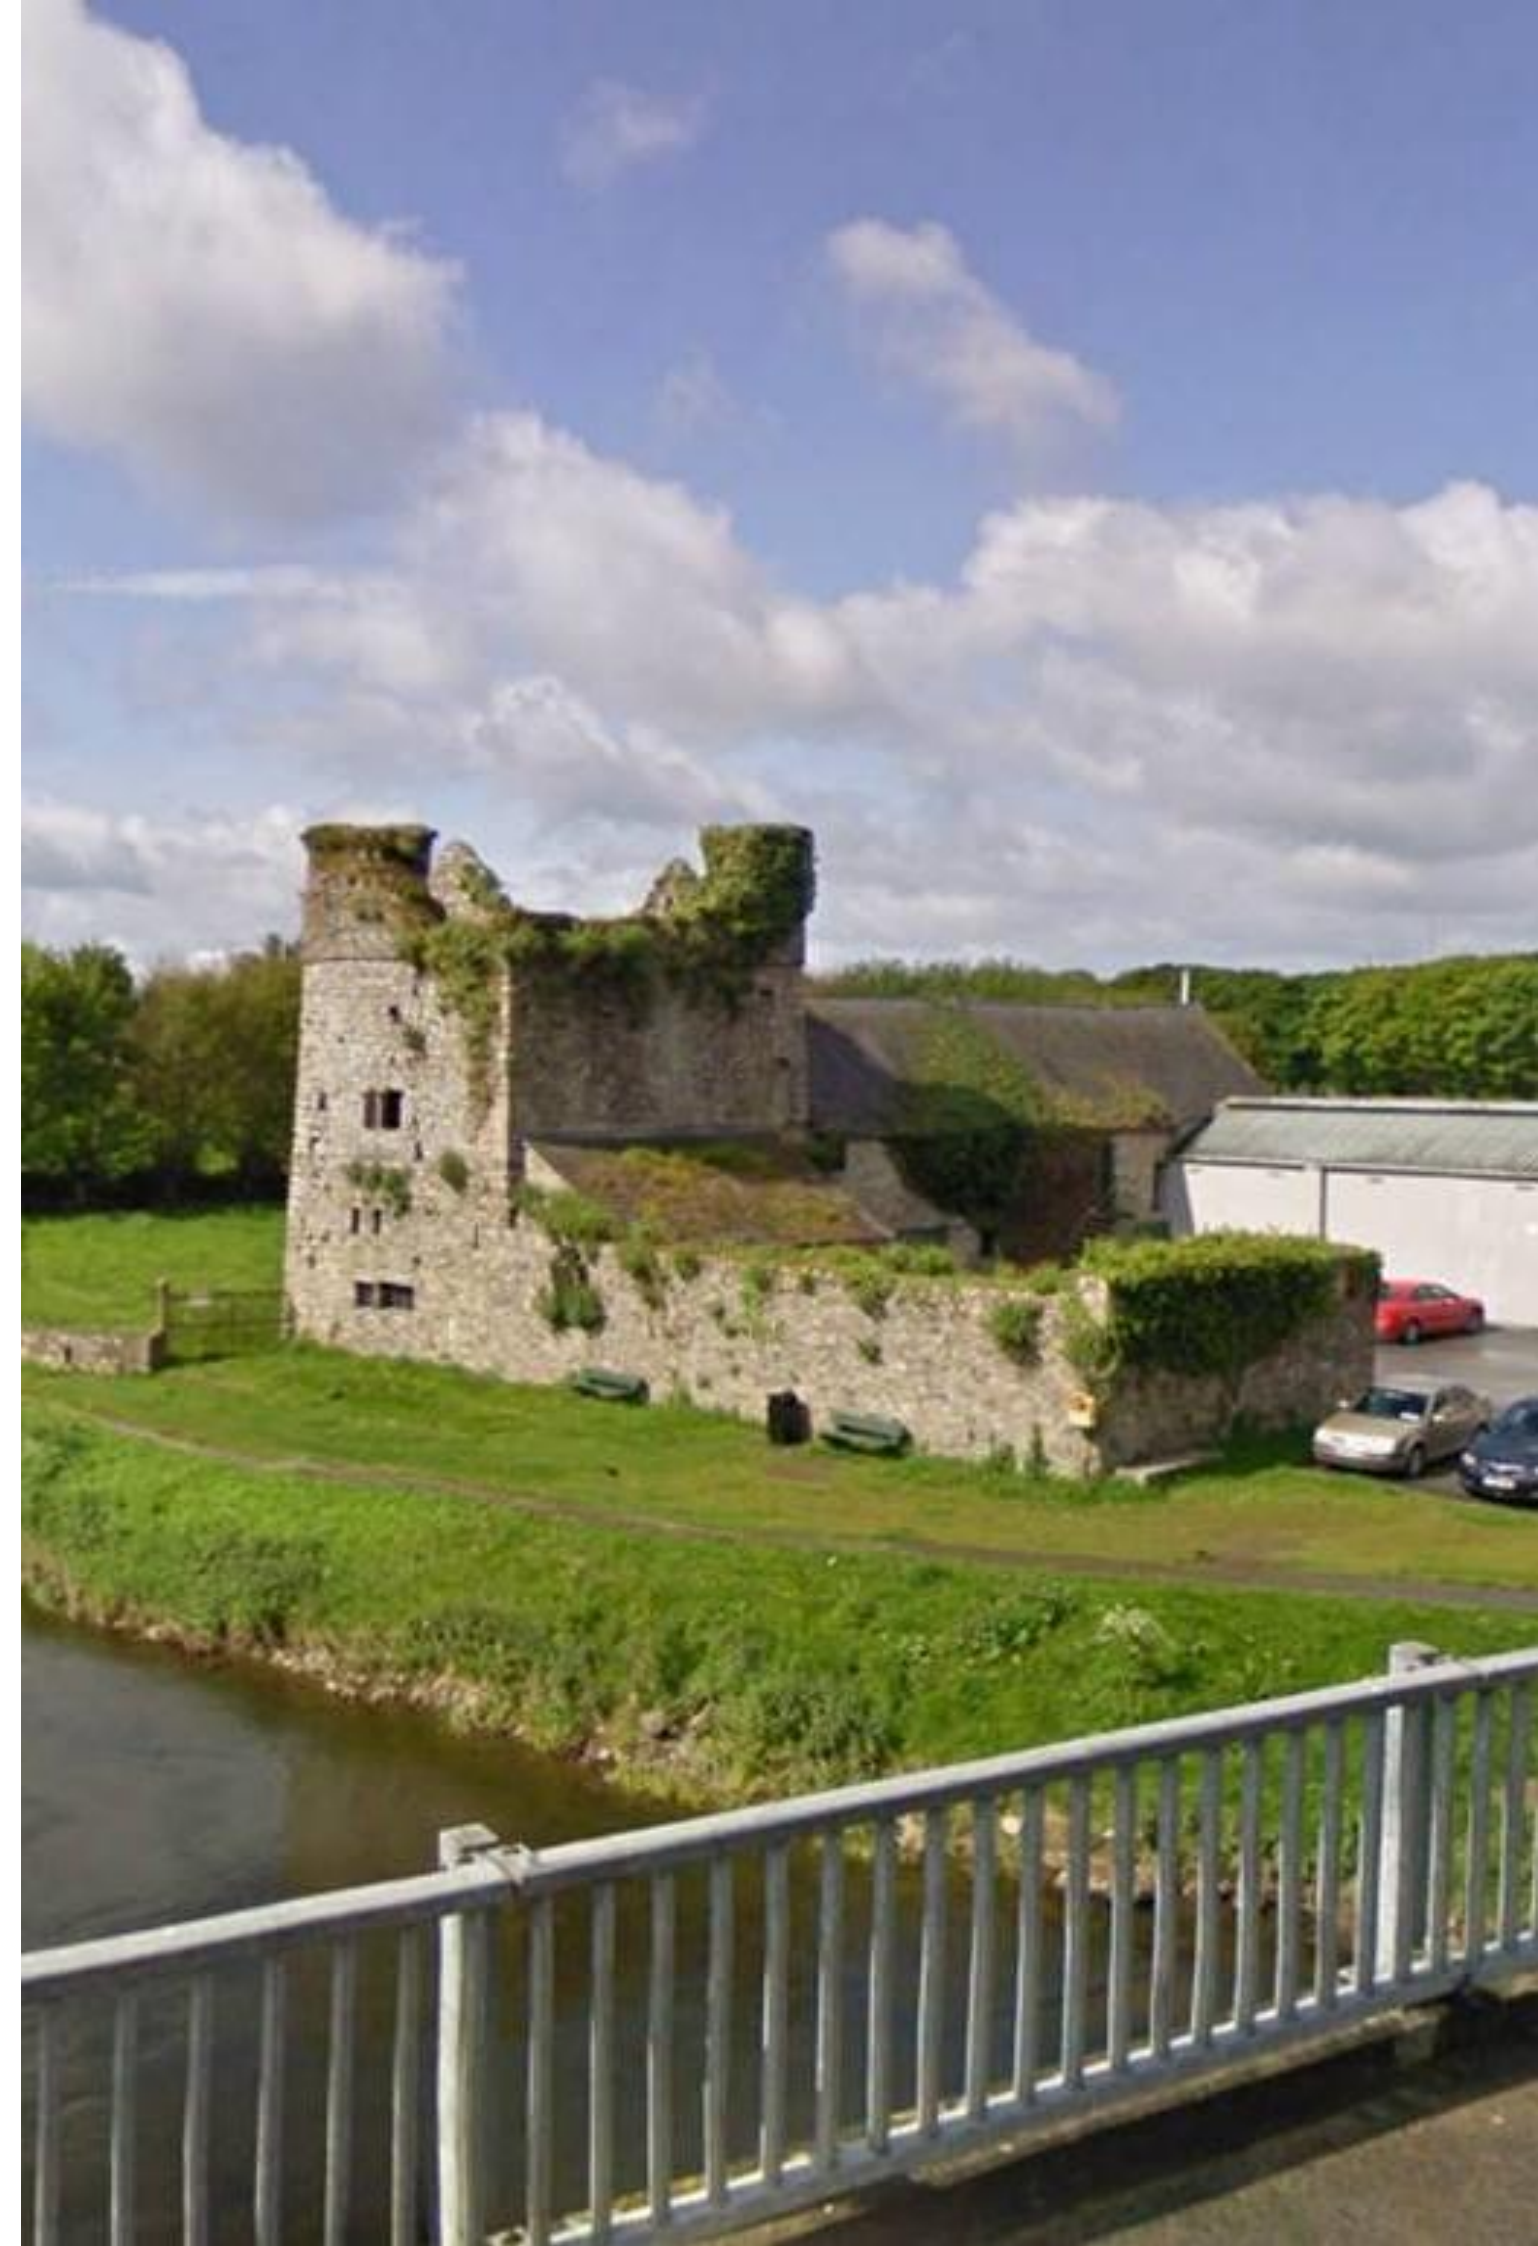
Emo Court Folly

In the ownership of Coillte, this is an impressive folly (circa 1760) is part of the Emo Demesne located on a distant hill in the park, now hidden by trees and becoming overgrown by vegetation. The structure is now in ruins with structural movement to the upper portico. No long term conservation management plan is proposed to secure its future.

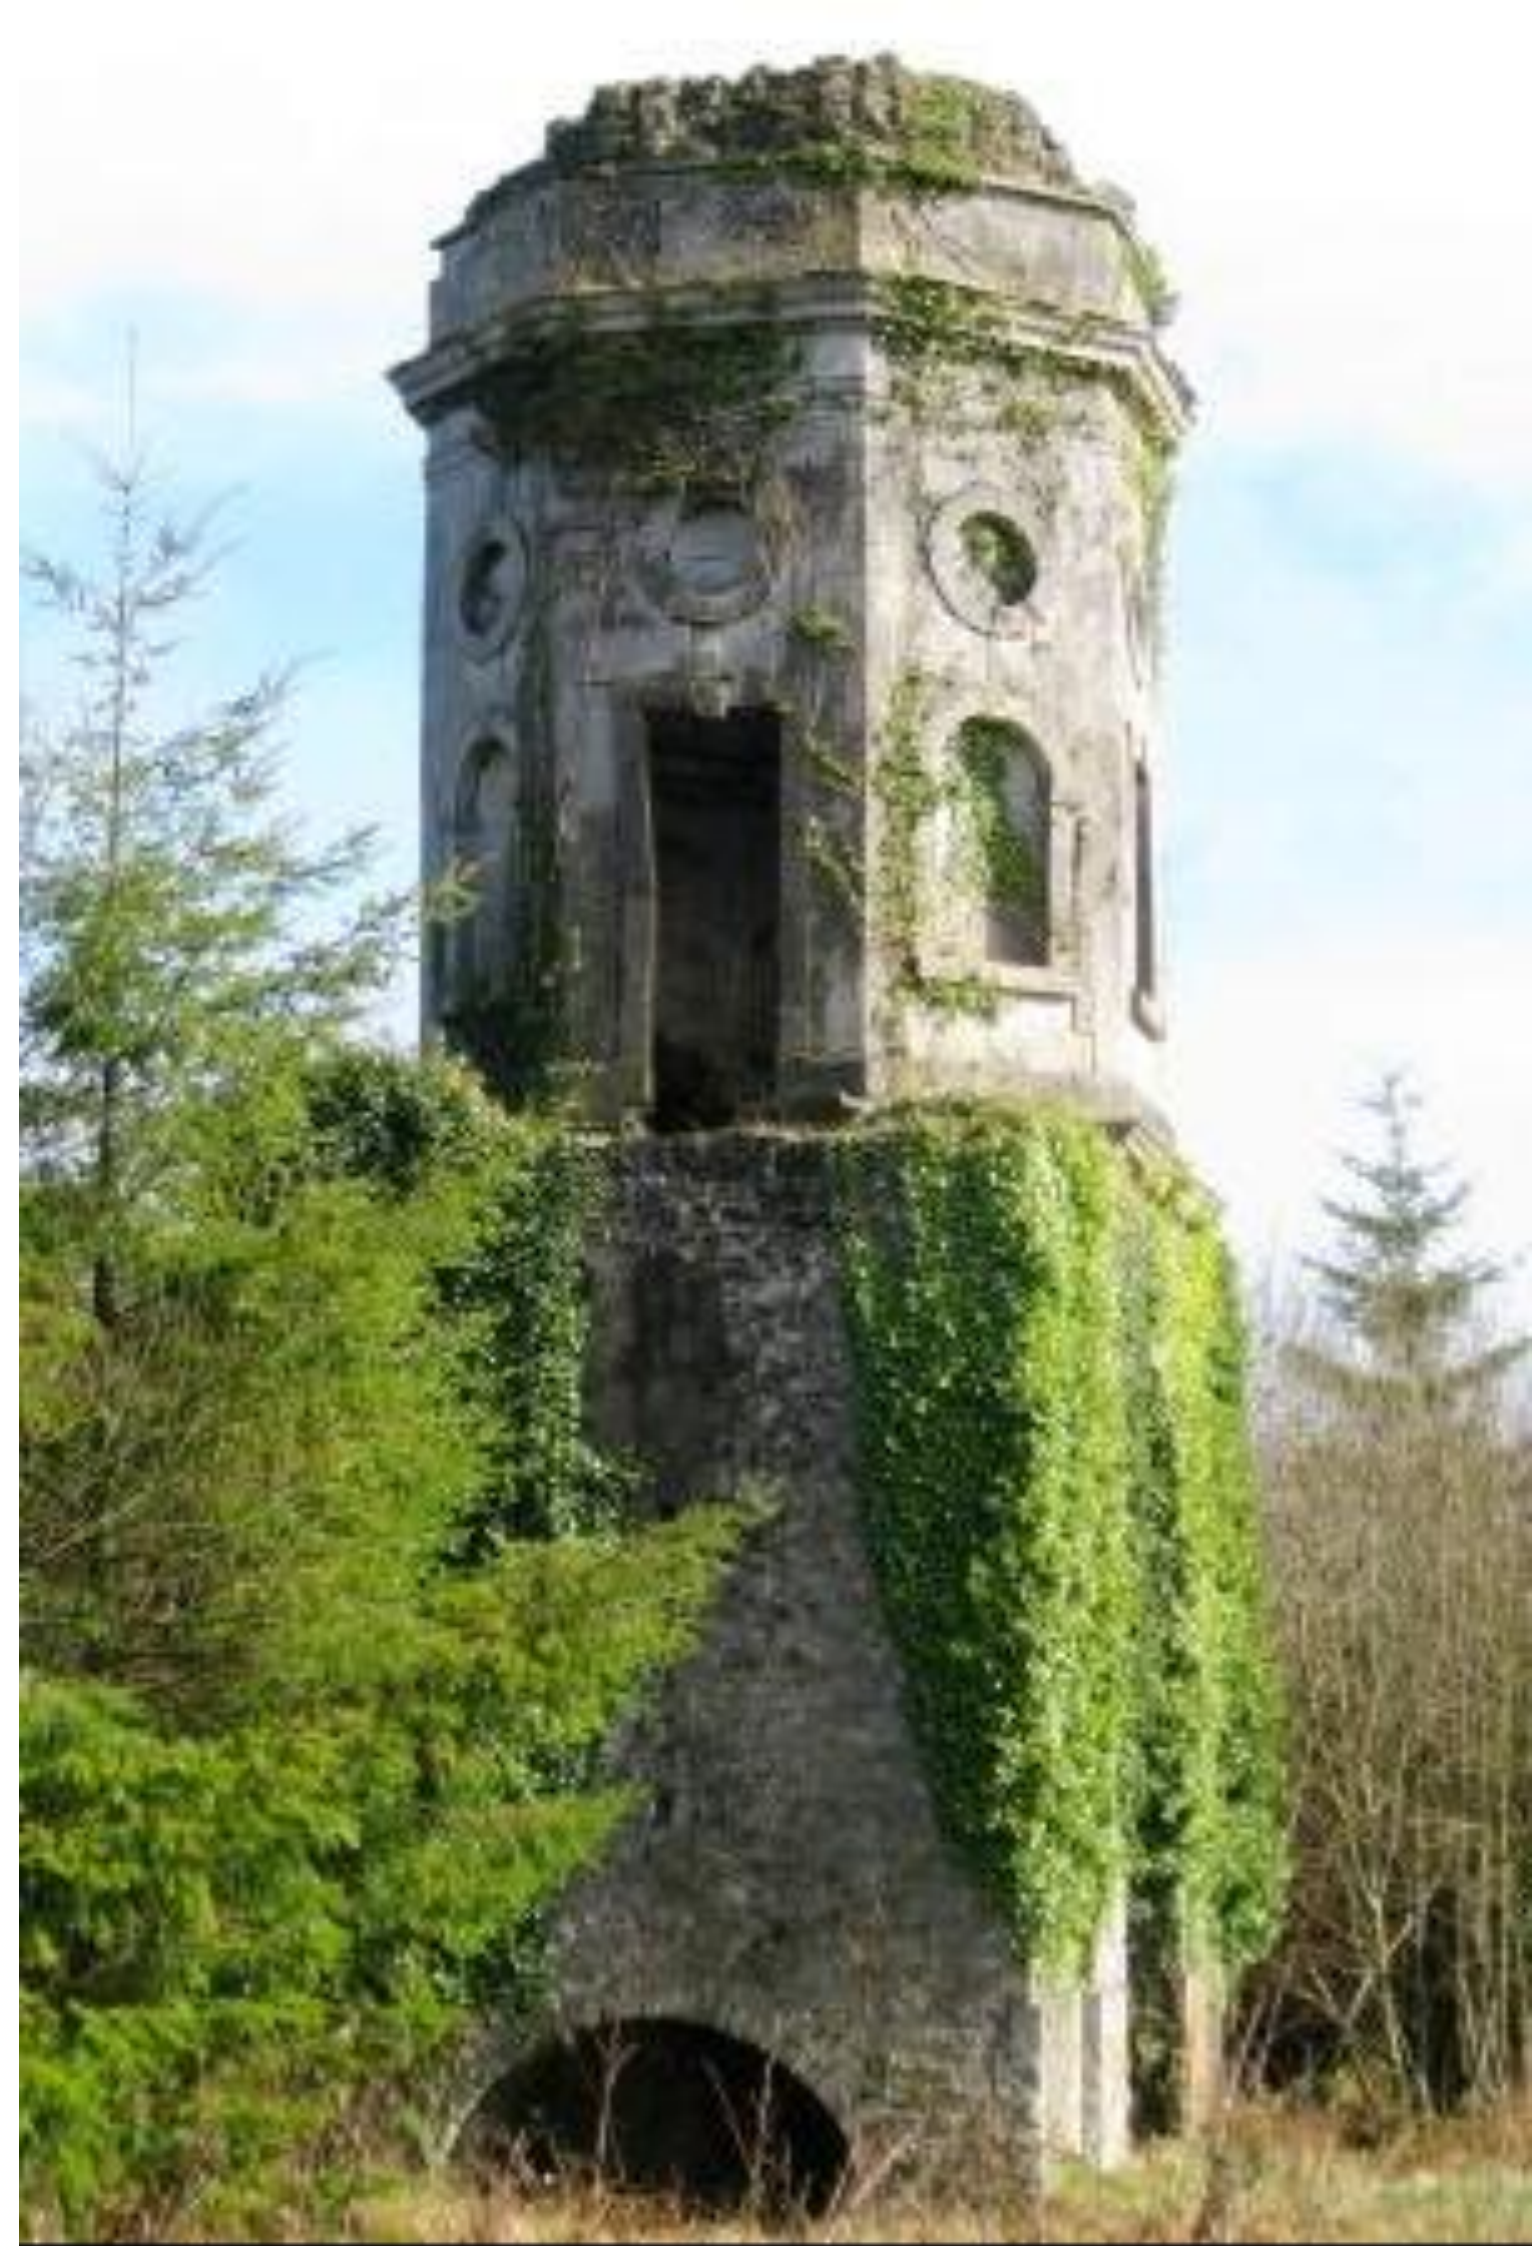
Arlington House

Arlington was constructed in two periods. Early 18th century house to rear, with later 18th century house to front with pedimented centre piece. The building functioned as a school during the late 19th century. Following over twenty years of dereliction, the building is now a shell. This building urgently requires new uses to be identified to prevent further deterioration of its character.

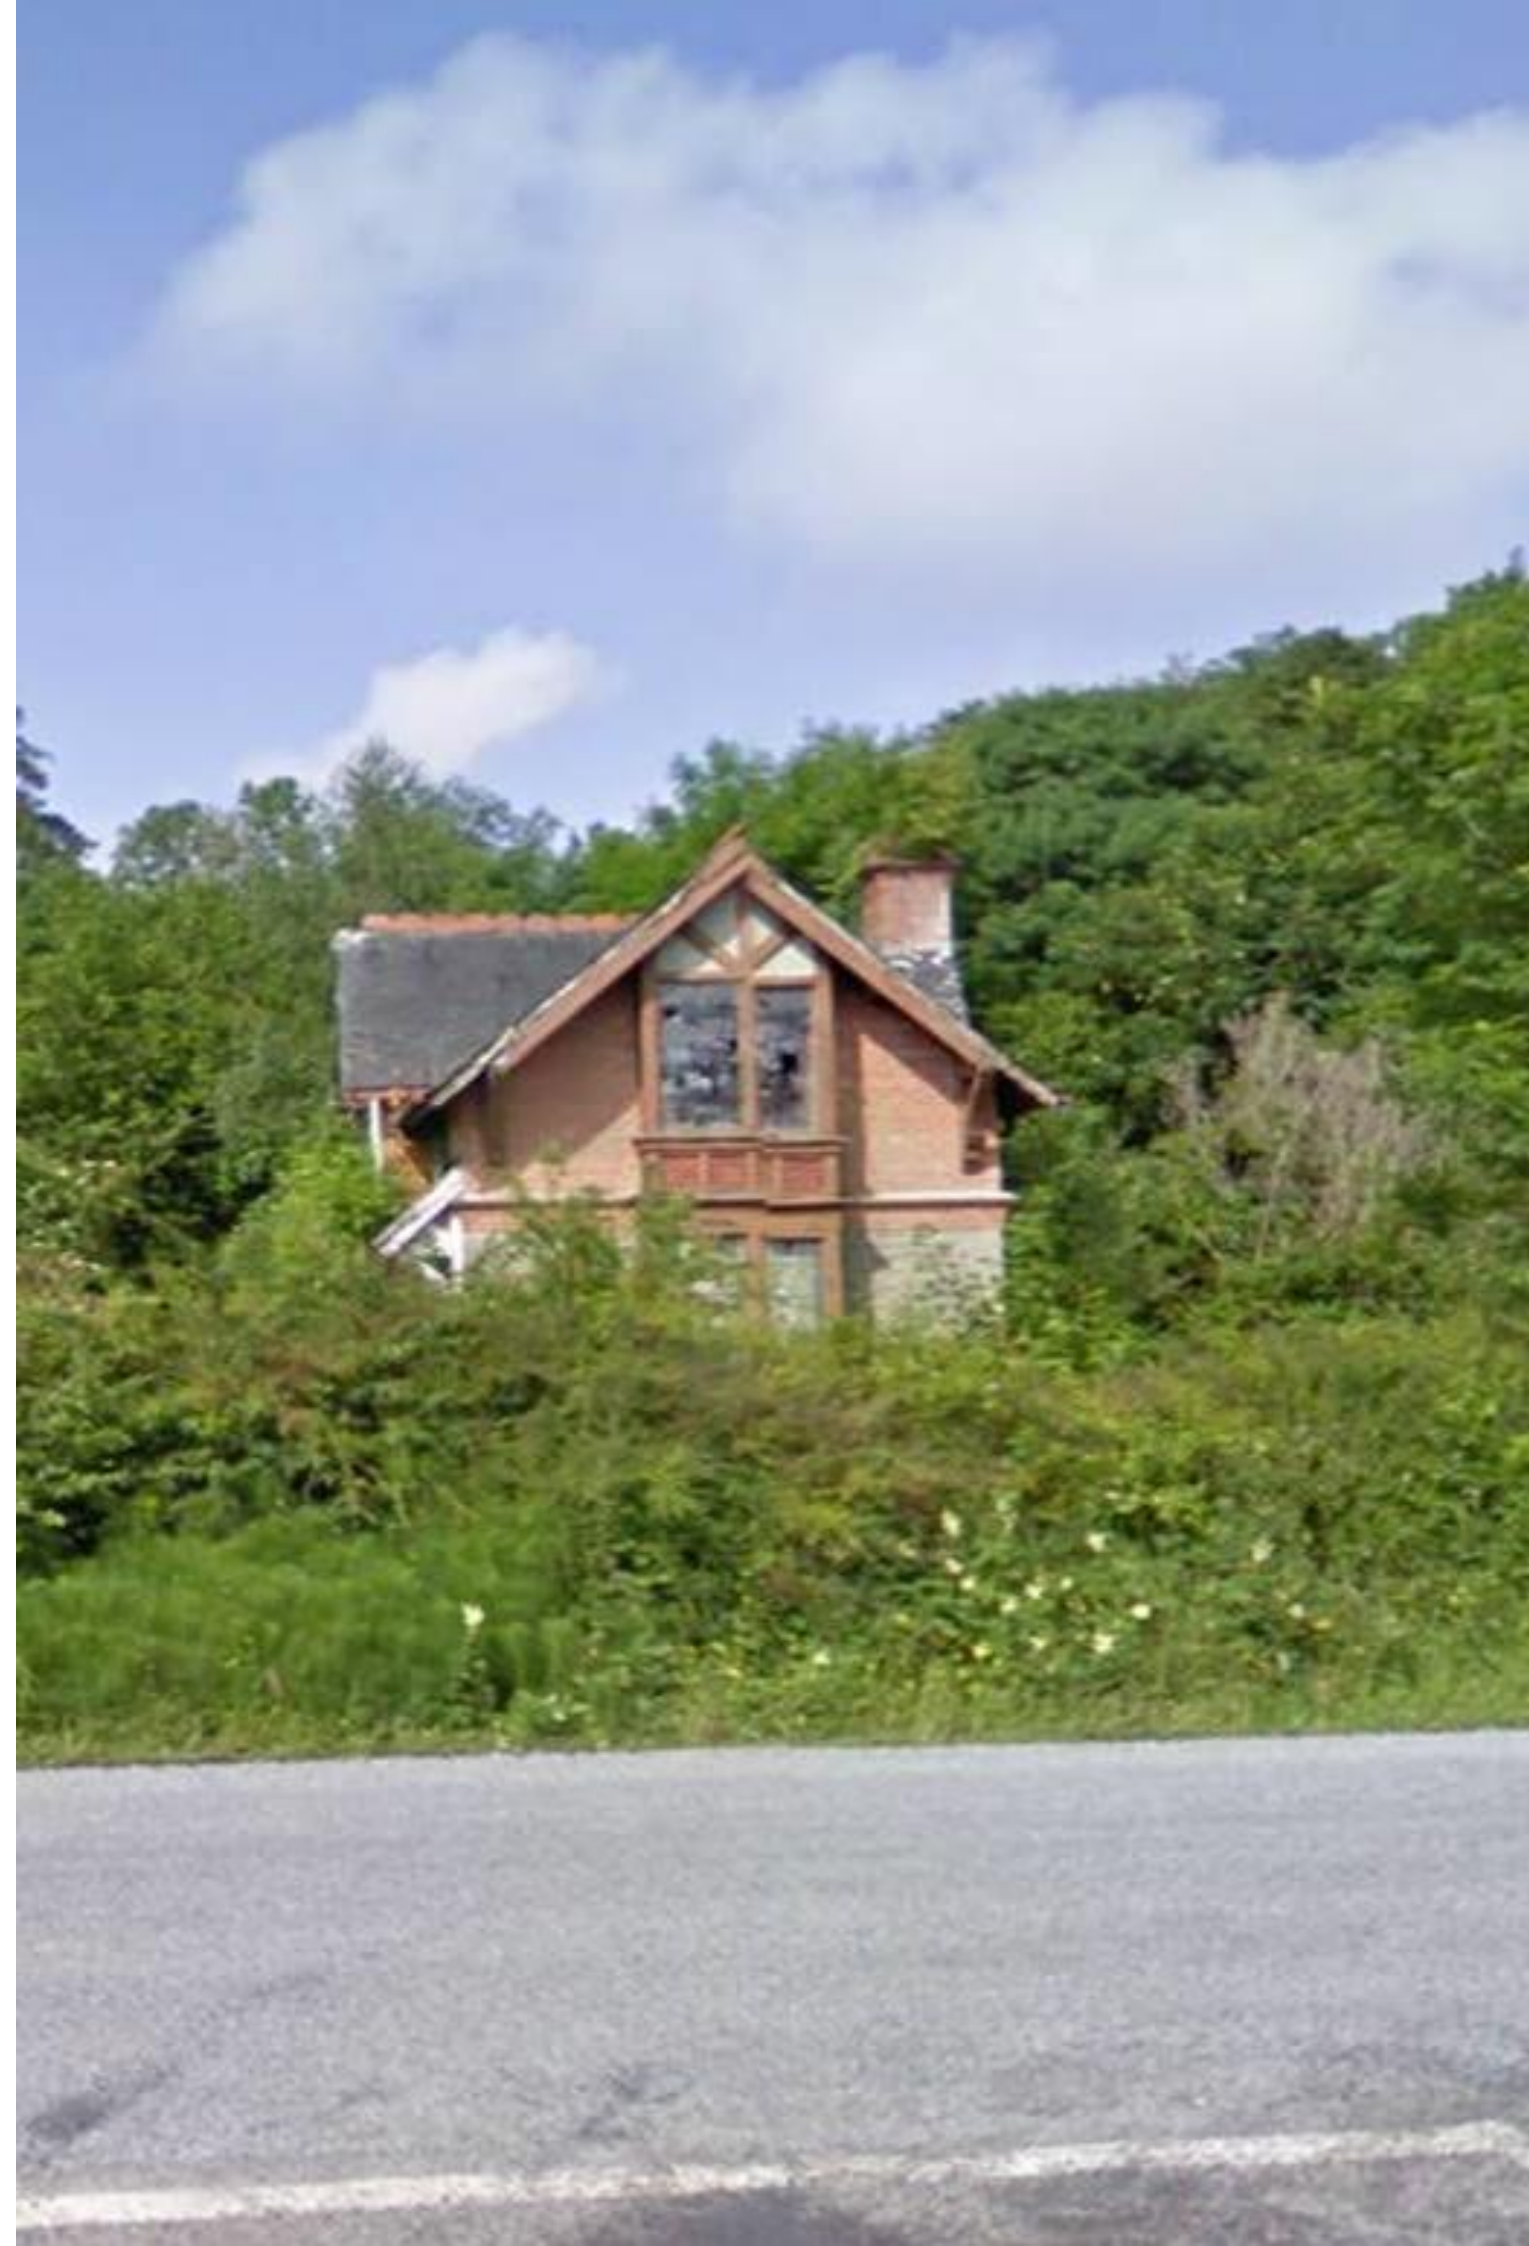
Mount Shannon

The ruin of a mid 18th century house extended in the 1790s by John Fitzgibbon later the Earl of Clare. It has impressive iconic porticoes. The house was burnt circa 1920 and part of the main block to side of portico has collapsed or been demolished. The building is of significant historic importance and requires conservation works to prevent further deterioration.
